# Manhole Inspection Summary

Manhole # S33KK\_021MH

Insp Date: **12/6/06 9:55 AM**

**Location** Address: **1731 CHARLES ST**

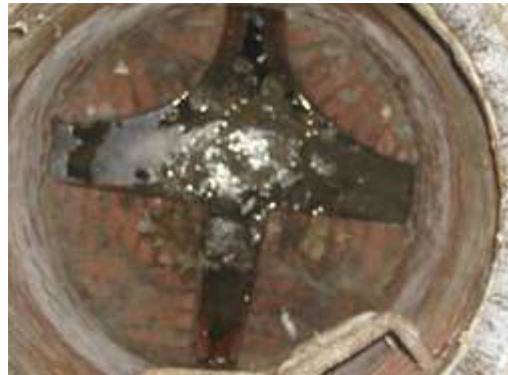
Top View

Evidence of surcharge - Bench debris.  
Channel debris.

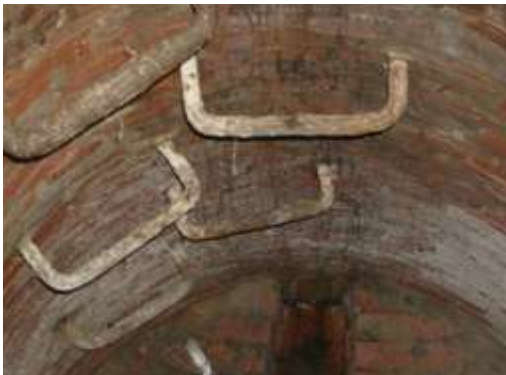
Defect

Infiltration: ☐ None ☒ **Joint** ☐ Cracks ☐ Mortar ☐ Roots ☒ **Wall**

Infiltration: ☐ None ☐ Joint ☐ Cracks ☒ **Mortar** ☐ Roots ☒ **Wall**

Count: **5** Missing: **0** ☒ **Corroded**

Adjustment and Barrel infiltration.  
Corroded steps.

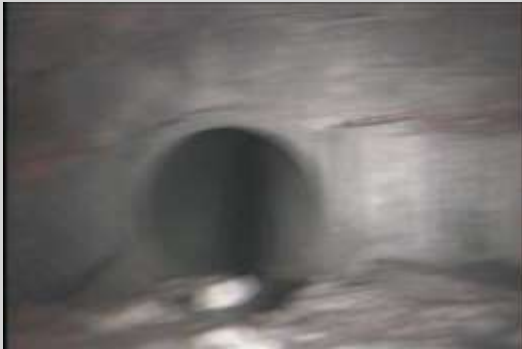
### 8 in. Circular Gravity Sewer Pipe Out @ 12 O'Clock

Deposits: ☐ None ☒ **Mud** ☐ Sludge ☒ **Debris** ☐ Grease

Silt Depth: **0** (in.) Deposits Extent: **Light**

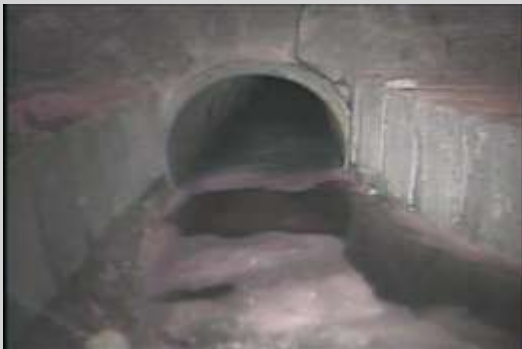
### 8 in. Circular Gravity Sewer Pipe In @ 3 O'Clock

Infiltration: **Evidence** Pipe Seal Cond: **Cracked**

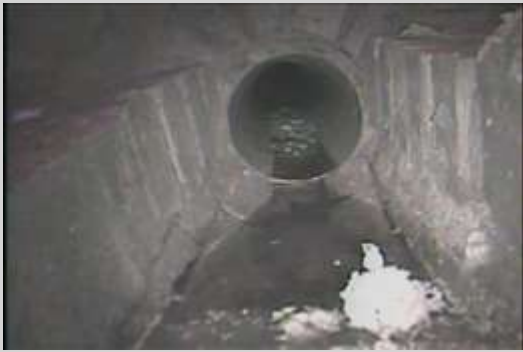
Pipe In @ 6 O'Clock

Deposits: ☐ None ☒ **Mud** ☐ Sludge ☒ **Debris** ☐ Grease

Silt Depth: **0** (in.) Deposits Extent: **Light**

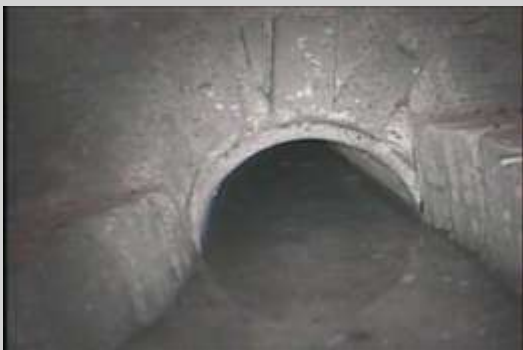
Pipe In @ 9 O'Clock

Deposits: ☐ None ☒ **Mud** ☐ Sludge ☒ **Debris** ☐ Grease

Silt Depth: **3** (in.) Deposits Extent: **Medium**
